## Catalina 27 Lower Shroud Chainplate Eyebolt Retrofit Kit Installation

By Carl Schaefer C27 Hull # 2021, s/v "Extra Special"

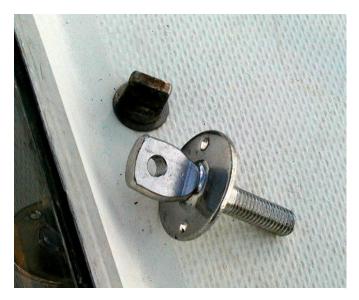
When you receive the new eyebolts you will immediately notice the physical differences from the eyebolts they replace. Specifically, the new eyebolt shank diameter is 1/2 "while the shank of the old eyebolts measures 3/8". The new eyebolts are also slightly longer and have large, circular flanges to prevent the eyebolt bearing surface from compressing into the deck and to provide a large surface area for sealant. Two screw holes are drilled into the flange for a pair of wood screws that are used to set the new eyebolt into the deck. These screws prevent the new eyebolt from twisting and prevent breaking the caulk seal bond between the deck and the eyebolt flange. One disappointing aspect of the retrofit eyebolt kit is that the cabin backing plates provided with the kit are smaller, both in surface area and in thickness, than those that they replace. The smaller

surface area of the new backing plate does not allow a wider distribution of the lower shroud loads over a larger bearing surface. Some C27 owners have retained their old backing plates as a substitute for the new ones or they use both plates in combination and sandwich them together with the larger of the two plates bearing against the cabin roof. If the old plates are retained for the new installation, be advised that you will need to increase the diameter of the backing plate holes from 3/8" to ½" to accommodate the new eyebolts. A picture showing both the old eyebolt (installed) and the retrofit eyebolt is shown in Figure 1.

Figure 1 Old vs. New. The new eyebolt has a much larger flange, a larger cross section, and two screw holes to prevent eyebolt rotation.

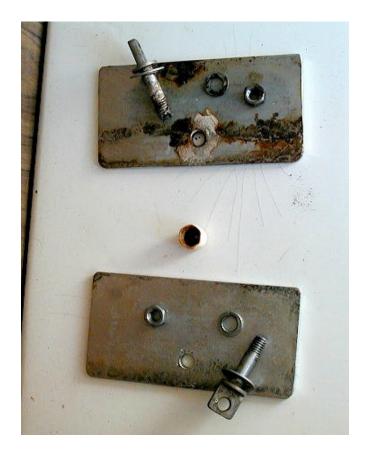
Inspection of the old eyebolts revealed that <u>none</u> of them had any significant sealant or caulk remaining. It was a surprise to discover that the deck was dry despite the absence of caulk. I also noticed that, for whatever reason, the aft eyebolts and plates were corroded whereas the forward eyebolts and plates appeared were virtually blemish-free and looked nearly new.

Figure 2 Old eyebolt backing plates. Starboard aft plate top, starboard forward plate bottom.

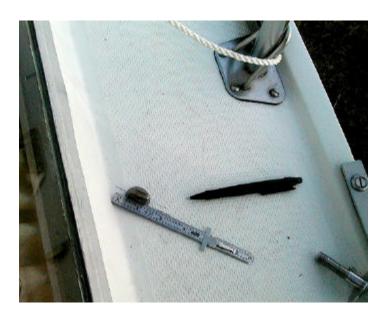
Figure 4 Marking the orientation of the old eyebolts prior to removal.

- 2. Using your pencil and straightedge, carefully mark the orientation of the original eyebolt <u>before</u> removing it from the boat (see Figure 4). This will ensure that the new eyebolts will be oriented exactly as the bolts they are replacing. This step is important since even a small deviation from the ideal orientation relative to the mast will place a twisting moment on the new eyebolts, possibly shearing off the eyebolt flange wood screws (or worse, ripping out a small section of fiberglass deck). Do this for each eyebolt before proceeding with the retrofit.

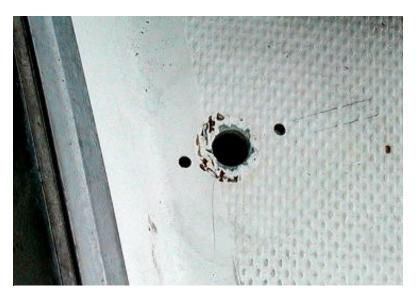
Figure 5 Old eyebolt removed. The hole has been enlarged to accept the new eyebolt and the two screw holes have been drilled through the deck and core using the new eyebolt as a template.

- 7. Insert and dry-fit the new eyebolt into the enlarged hole but do not apply sealant at this time. Align the new eyebolt with the alignment marks and, using the eyebolt as a template, carefully drill the two holes for the eyebolt flange screws using a 5/32" drill bit (see Figure 5. Note the alignment marks to the right of the ½" hole and the two 5/32" holes for the flange screws). Hint: to avoid drilling completely through the deck for the 5/32" screws, it would be prudent to carefully mark the drill bit with a piece of masking tap as a depth gauge.

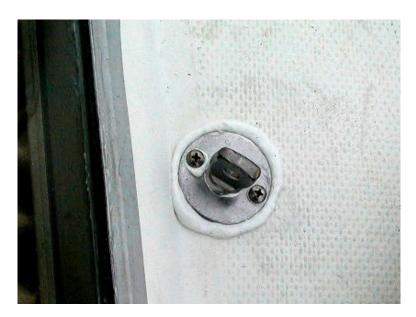
Figure 6 New eyebolt installed with 3M 4200 sealant squeezing out from beneath the flange. Cure time varies.

- 11. Back down in the cabin, quickly install the backing plate, the flat washer, the locking washer, and the nut, in that order, before any sealant in the eyebolt threads has a chance to cure. Thoroughly tighten the eyebolt nut. Go back on deck and completely tighten the eyebolt flange screws. The newly installed eyebolt is shown in Figure 6 before the sealant has had time to cure.

- 12. Do not wipe up the sealant from around the flange; let it cure first. When the sealant has cured, use a sharp razor blade to carefully trim and remove the sealant that has squeezed out from beneath the flange.

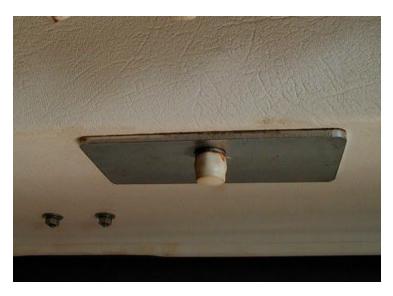
- 3. When you have marked the orientation of each eyebolt, move to the cabin and remove the eyebolt nut using a 9/16" wrench or socket. Remove the locking washer and backing plate. You may notice, as I did, that the backing plate has corroded somewhat from moisture trapped between the plate and the cabin ceiling. The resulting rust stain on the cabin ceiling is very difficult to remove but should be done before you install the new eyebolt (see Figures 7 and 8). While removing the rust stains left by the old backing plate, you may want to leave the old eyebolt in place to avoid water trapped in the core from draining into the cabin while you're working.

Figure 7 Old eyebolt backing plate, aft starboard.

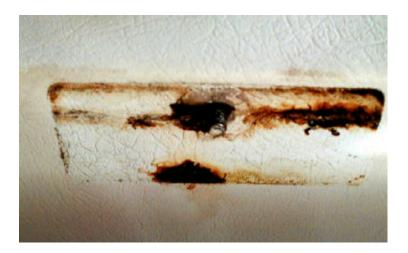
Figure 8 Rust stains left on cabin ceiling from old backing plate – clearly water had made it into the cabin and core at one time.
