## Catalina 27 Lower Shroud Chainplate Eyebolt Retrofit Kit Installation

By Carl Schaefer C27 Hull # 2021, s/v "Extra Special"

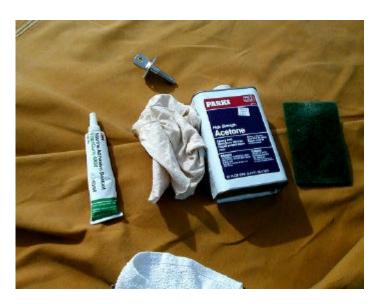
- 3. When you have marked the orientation of each eyebolt, move to the cabin and remove the eyebolt nut using a 9/16" wrench or socket. Remove the locking washer and backing plate. You may notice, as I did, that the backing plate has corroded somewhat from moisture trapped between the plate and the cabin ceiling. The resulting rust stain on the cabin ceiling is very difficult to remove but should be done before you install the new eyebolt (see Figures 7 and 8). While removing the rust stains left by the old backing plate, you may want to leave the old eyebolt in place to avoid water trapped in the core from draining into the cabin while you're working.

Figure 2 Old eyebolt backing plates. Starboard aft plate top, starboard forward plate bottom.
